# Tputty 607 Thermal Reliability

This report summarizes the thermal reliability testing of Tputty 607. This reliability test procedure is designed to characterize the long term performance of the dispensable thermal gap filler by subjecting the material in the test fixtures to isothermal conditions, repeated thermal shock conditions, and moderate heat and high humidity conditions. The test fixtures feature an isolated sample platform with an area of 12mm x 14mm. Three of these isolated sample platforms are featured on a single test fixture with isolated heating and temperature monitoring for each sample.

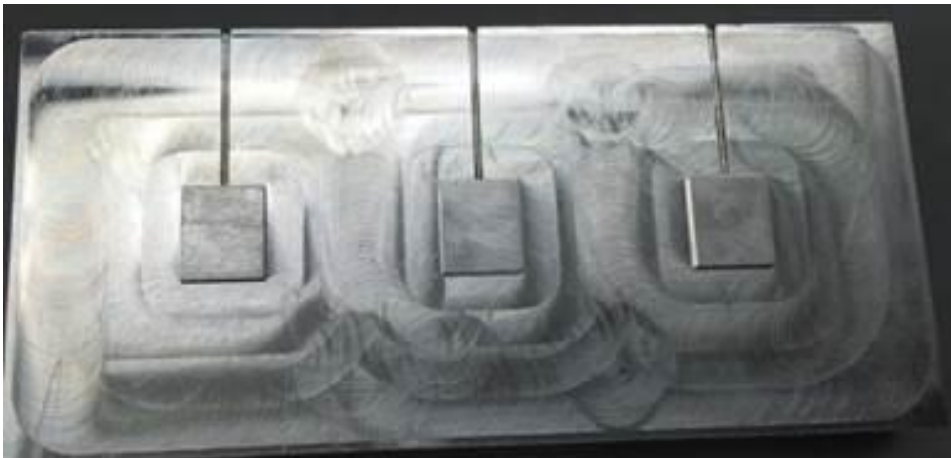
**Figure 1: Test Fixture Hot Plate Sample Surface**

Each assembly, with sample, is tested at time zero and then placed into the conditioned chambers for the specified period of time. Generally, every 250 hours the assembly is removed, tested and then placed back into the chamber. Figure 1 shows a detail of the hot plate surface, providing a visual of the isolated and raised sample platform. See figure 2 for an image of the test fixture with dual fan in place for testing.

The test fixture is a rectangular fixture with dimensions of approximately 2 inches x 5 inches, or 10 square inches. It consists of an aluminum hot plate and an extruded aluminum heat sink. The hot plate has three machined holes at even intervals for insertion of cartridge heaters. Both hot plate and heat sink have three smaller precision machined holes for thermocouples. The thermocouples can be inserted in very close proximity to the surface of the plates and precisely in alignment for each set of “hot” and “cold” thermocouples. The sample is placed on the 12mmx14mm raised pedestals (0.1mm height) on the hot plate surface and the fixture assembly is fastened by two metal straps. Each test fixture accommodates 3 samples of 12mmx14mm. Final testing gap was set by using metal shims of appropriate height to achieve a sample gap of 1.5mm. During testing, a dual fan unit is placed on top of the aluminum heat sink and air flow is directed from the heat sink to the atmosphere. The completed assembly is operated in an ambient laboratory environment. Once fully assembled, the cartridge heaters are connected to a power supply and power is applied to maintain a hot plate sample temperature of approximately 70°C across the hot plate surface. This is monitored by the data acquisition system. Steady state condition is achieved in approximately forty five minutes to one hour.

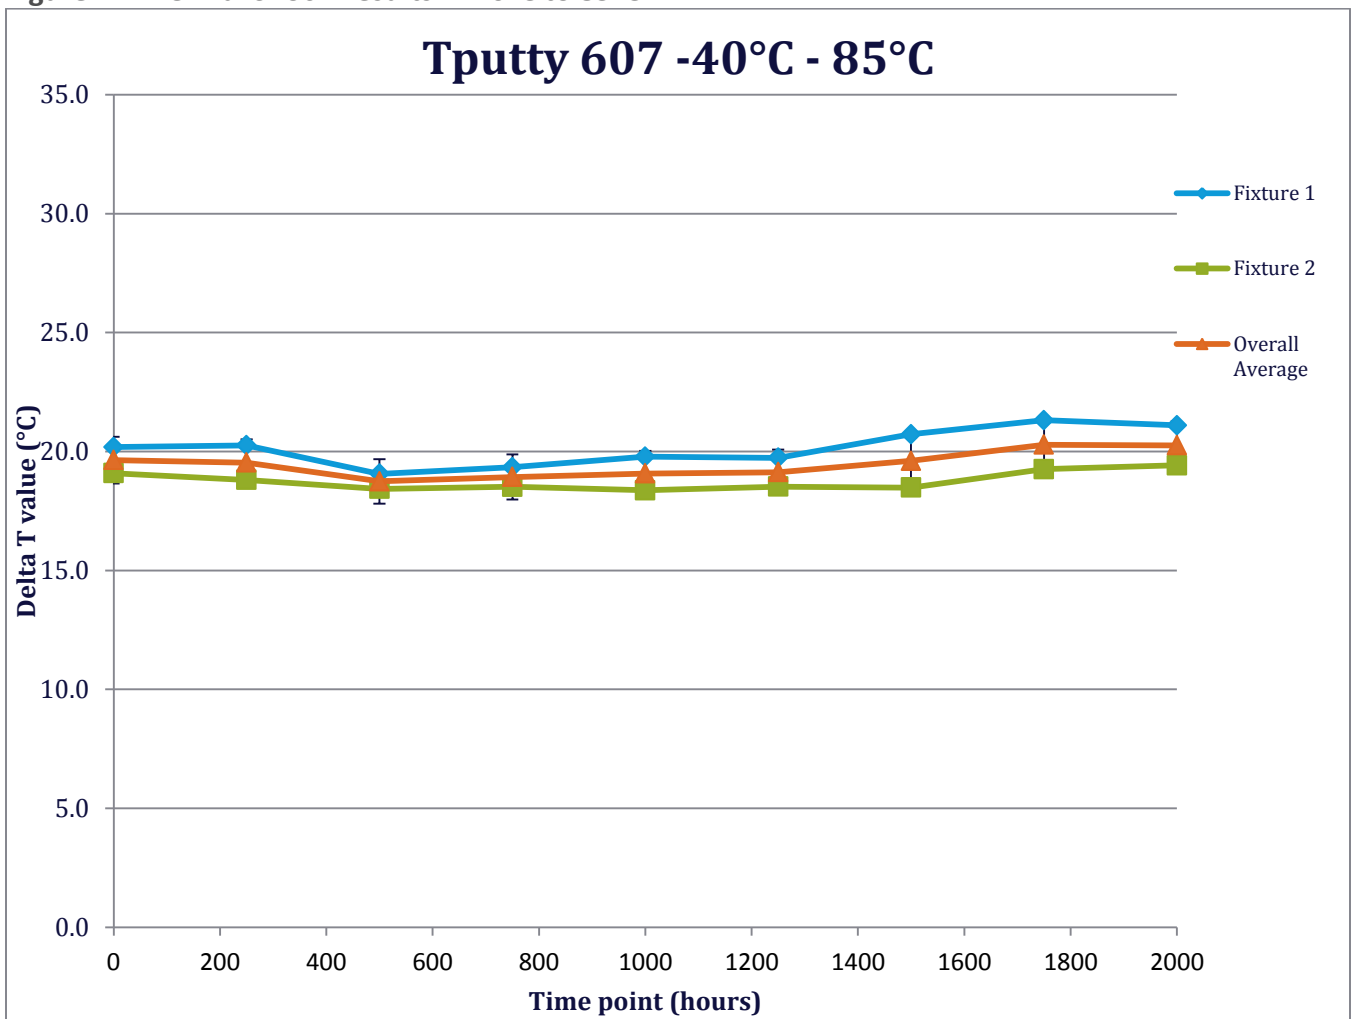
Figure 4: Thermal Shock Results – -40°C to 85°C

Thermal shock was performed for 2000 cycles from -40°C to 85°C and for 2000 cycles from -40°C to 125°C . Each cycle is one hour, with the assembly spending thirty minutes at each condition. The sample transition time between the two temperature extremes is approximately 10 seconds. The thermal shock conditions had 1 gap size in a horizontal orientation with 2 test fixtures in each condition. See figures 4 and 5 for thermal shock results.

In conclusion, Tputty 607 showed very little change in temperature differential ( $\Delta T$ ) in all aging conditions. The results indicate that the material will be a reliable thermal interface material and will continue to perform well under rigorous conditions similar to those simulated in this report.
